Structural Behavior of Recycled Aggregate Concrete Continuous Beams

The structural behavior of continuous recycled aggregate concrete (RAC) beams under point loading at each span is examined experimentally in this work. Nine continuous beams, each 225 mm deep, 150 mm wide, and 3000 mm long, were tested as part of the program. As references, there were two beams made of normal concrete, one intended for shear failure and the other for flexural failure. Three beams were cast with different replacement ratios of recycled concrete Aggregate (20%, 40%, and 70%) to assess the effect of RAC content. The impact of RCA placement was also investigated using two flexure-critical beams and two shear-critical beams, each developed with a particular recycled aggregate location. The main experimental parameters included steel fiber, the position of recycled Aggregate, and the ratio of recycled aggregate replacement.

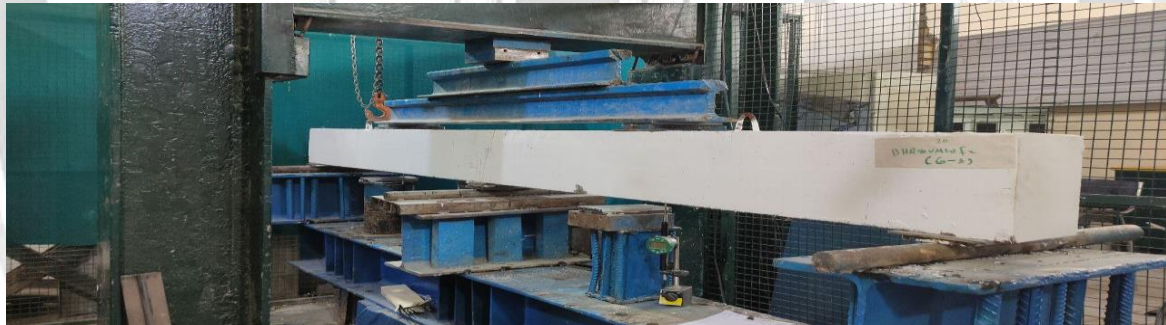
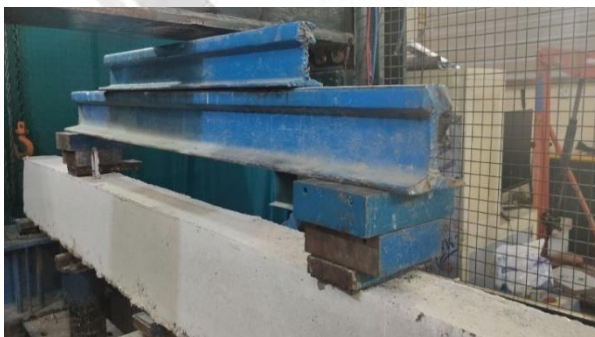
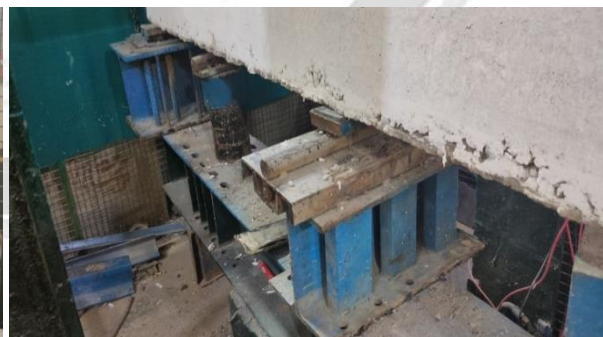
Fig (6) test setup

After 28 days, the specimens were painted white before testing to distinguish the crack propagation. A universal testing machine tested the 10 continuous beams at the University of Kufa. The capacity of the machine is 2000 kN. A bearing plate was put under each point load to distribute the load from rigid beam to beam, as shown in Fig (5(b)). The continuous beam is fixed above three supports, two roller supports (achieved by using steel shift) at a distance 100 from the edge of the beam, and a hinged support at the center of the beam. To avoid crushing the concrete, the rubber plate with dimensions (100x150x6mm) and the bearing plate with dimensions (100x150x15mm) were utilized at supports, as shown in Fig (6(c)). The deflection was measured using 2 dial gages with an accuracy of 0.01 fixed at each mid-span of the continuous beam. A blackboard pen was utilized to indicate the propagation of the crack. The setup of the beam is shown in Fig (5(A)). A crack meter was used to measure the crack width.

A) preparation of the specimen for testing

b) loading point

C) supporting point

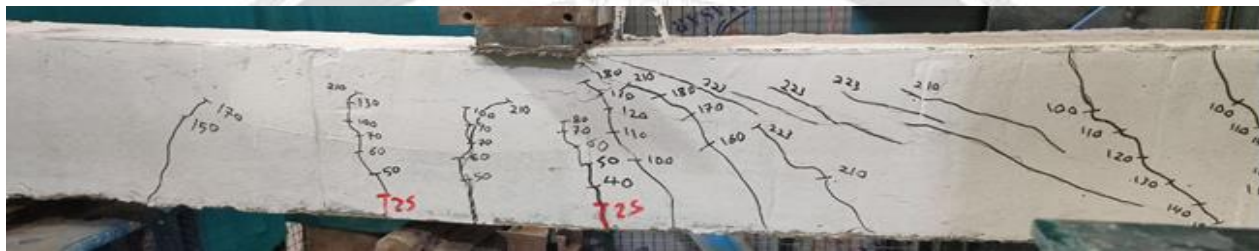
Fig (7) crack patterns and failure mode of specimen BROF1

Specimen BR0F1 was considered the control beam for this group, which used conventional concrete without steel fibers. When the load is applied gradually, a flexural crack appears at a load of 25 kN (11% of the ultimate load) at the mid-span of the beam. As the load increased, new cracks formed at the middle support section at 50 kN (22.4% of the ultimate load), and existing cracks propagated vertically and widened. Then, the inclined tensile crack appears at mid-span and at the middle support at 100 kN (45% of the carrying capacity). After that, at 210kN (94% of the ultimate load), the formation of cracks stopped, and the first crack

widened until the flexural failure load occurred at the middle support at 223kN. The crack pattern and failure mode for specimen BROF1 are shown in Fig (7). Because tensile cracks began, propagated, and widened considerably in the tension zones (mid-span and middle support) as the load increased, the continuous beam with normal concrete (BROF1) displayed flexural failure (tension failure). According to the description, the cracks widened until flexural failure occurred, suggesting that the steel reinforcement's tensile capacity was reached and utilized, resulting in the ductile failure typical of tension-controlled flexural failure in under-reinforced concrete beams.

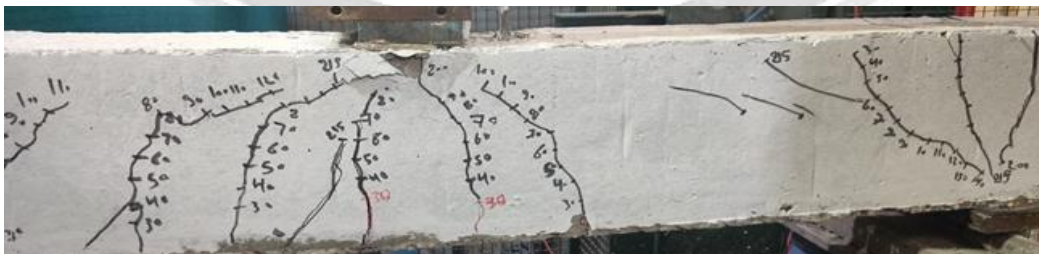
Fig (8) The failure mode and crack pattern for specimen BR20F1

In Group 1, the first crack appears in the mid-span region and at the middle support of the specimen. As the load increased, the crack initially propagated and widened, and a new inclined crack emerged as the load continued to rise. The inclined crack extended to the compression zone and widened. After that, new cracks appeared in the mid-span region and middle support zone, and the existing crack propagated toward the compression zone until it occurred. The failure of the specimen in group one is due to compression failure, except for specimen BR70F1, which failed in flexure. The failure mode and crack pattern are shown in Fig (8---10). Table (17) shows the results of Group one. The majority of Group 1 specimens experienced compression failure due to the recycled aggregate concrete (RAC) in the compression zone crushing prematurely, despite having reached its maximum compressive strength. This occurred before the tensile reinforcement could completely yield or rupture, suggesting that the ultimate load-carrying capacity of the beam was limited by the concrete's compressive capacity, which is normally weakened by recycled aggregates (because of lower ITZ, higher porosity, and decreased inherent strength).

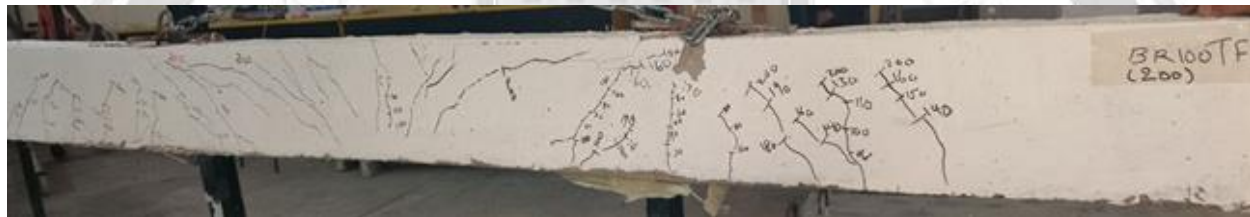
Fig (12) Crack patterns and failure mode of specimens BR100Tf

For group two, the initial crack in this specimen appeared mid-span in the tension zone. As the load increased, a new crack appeared in the positive moment region. As the load increased, a new inclined crack appeared on the left side of the positive moment region. After that, new cracks appeared at the middle support. Then, the initial crack and the existing crack propagated to the compression crack. At the late loading stage, the cracks ceased to appear, and existing cracks propagated and widened until failure occurred. All the specimens exhibit the same type of failure, which is compression failure..Because recycled aggregate concrete (RAC) has a weaker Interfacial Transition Zone (ITZ) and decreased compressive strength, stiffness, and ductility, the failure mode in RAC beams changes from ductile flexural (tension) failure in conventional concrete to more brittle compression failure.

In other words, because the RCA makes the concrete in the compression zone weaker by nature, it reaches its ultimate compressive strain and crashes before the tensile reinforcement can completely give and permit a ductile tension-controlled failure. Which particular area's weakness (compression vs. indirect effects in tension) determines this early compressive failure is further influenced by the shift in RCA placement (upper vs. lower). Fig (11) and Fig (12) show the crack patterns and failure mode of specimens BR100TF1 and BR100Bf. Table (18) shows the results of group two

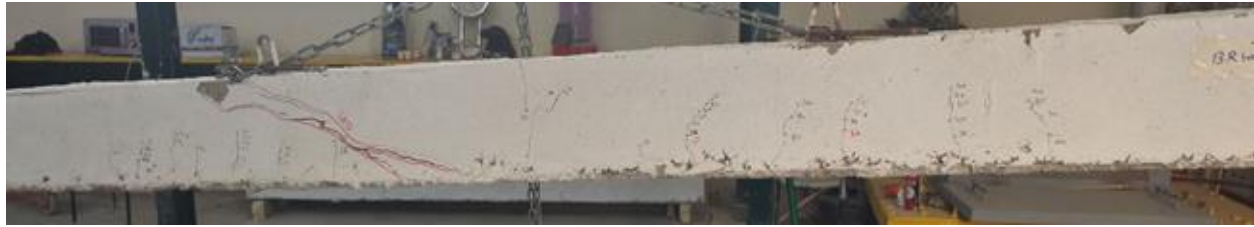
Fig (14) The crack pattern and mode of failure of specimen BR100bs1

For group three, the specimens began to crack in the mid-span region. The first crack gradually increased in width when the load continued to be applied, and a new crack formed in the mid-span region. After that, the crack at the middle support appeared. The failure for all specimens is similar. When the applied load increased, a sudden shear failure occurred between the support and loading point. The crack pattern and failure mode are shown in Fig (13---15). Table (19) shows the test results for group three.

The decreased tensile strength, decreased stiffness, and weaker Interfacial Transition Zone (ITZ) of recycled aggregate concrete (RAC) are the main causes of the altered crack pattern, particularly the inclined ones. Because of these characteristics, RAC is more vulnerable to diagonal tension strains than normal concrete beams, which may lead to inclined (shear-related) cracks forming more quickly, spreading more widely, and possibly becoming more prominent.

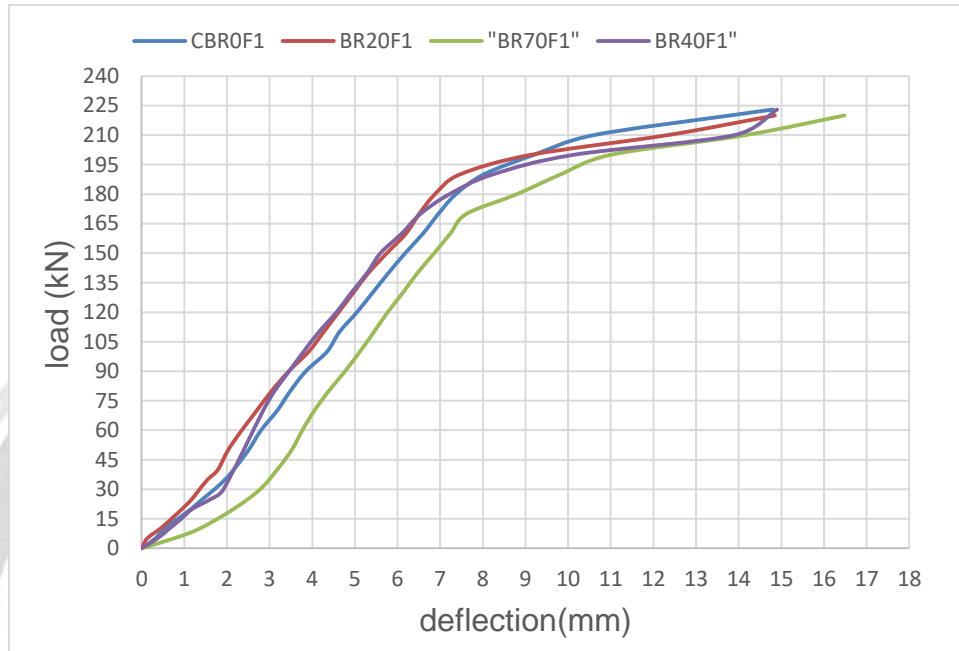
Fig (16) Effect of replacement ratio on the load-deflection curve

Load-deflection behavior for group one is shown in Fig (16). specimen, BR0F1, showed a linear load-deflection response. Figure 16 also shows that the specimens with lower RCA replacement ratios (20% and 40%) performed similarly to the control beam. However, the specimen with the highest RCA replacement ratio (70%) exhibited a different behavior. BR70F1 exhibited a higher deflection in the specimen than the control beam. This similar performance continued until a load of 200 kN. Beyond this point, the beams containing RCA exhibited increased deflection, reaching a load of 223 kN. At this load, the deflections of the beams with 20%, 40%, and 70% RCA were approximately 033%, 1%, and 11%, respectively, greater than the deflection of the control beam (BR0F1). In the control beam (BR0F1), the crack spread to the compression zone, causing a rapid increase in deflection. In contrast, RCA-containing beams produced more cracks than the control beam. This increased cracking contributed to the greater

- 6- The deflection of the beam with 20%, 40%, and 70% RCA was about 16.5%, 51%, and 52%, respectively, greater than the deflection of the control beam.
- 7- Adding steel fiber (with a volume fraction of about 1%) led to a decrease in deflection of about 15%.
- 8- The deflection specimen with recycled Aggregate in the compression zone was 27% higher than that of the specimen without recycled Aggregate

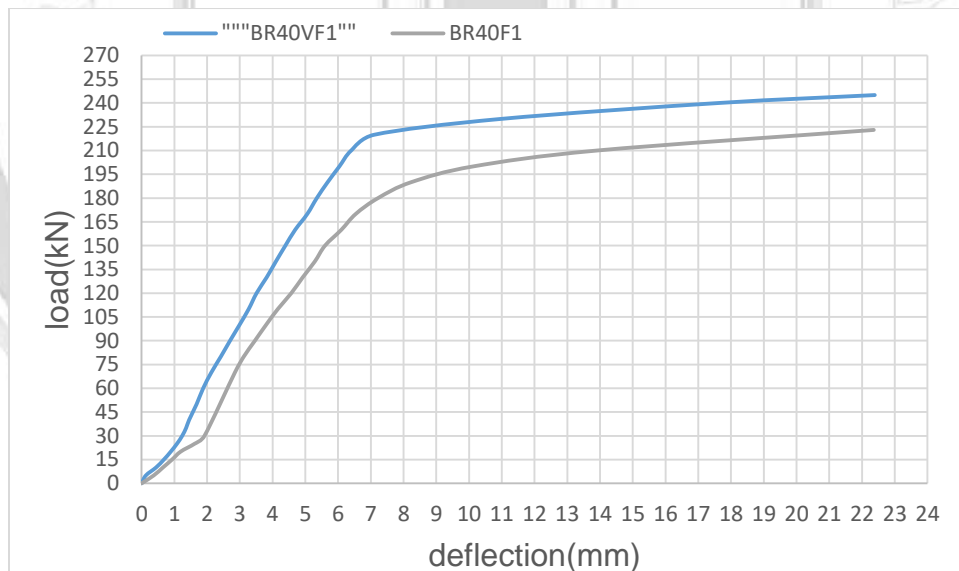
Fig (17) Effect of steel fiber on load-deflection curve

deflections noticed in the RCA sample. However, adding steel fiber decreased deflection by about 15% compared with specimen BR40F1, as shown in Fig (17).

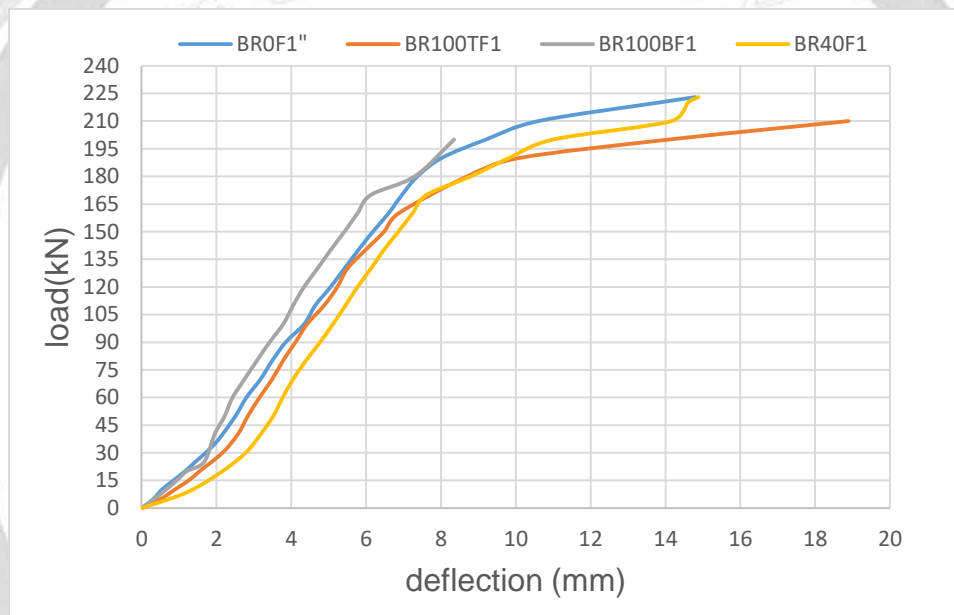
Fig (18) Effect of changing the location of RCA on flexural behavior

Figure 18 displays the load-deflection responses for the flexural specimens (BR40F1, BR100TF1, BR100BF1, and BR0F1), and Figure 19 shows the load-deflection performance of the specimens that were shear-tested (BR0S1, BR100TS1, and BR100BS1). Beam BR100TF1

(with RCA in the tension zone) showed a 27% more deflection in the flexural testing (Figure 18) than the conventional concrete reference beam, BR0F1. In contrast to BR100TF1, beam BR100BF1 (with RCA in the compression zone) displayed a 4.7% decrease in deflection. The presence of recycled aggregate in the tension zone, which is naturally an area of weakness in concrete, is the cause of this increased deflection, especially in BR100TF1. A noteworthy distinction was also noted for the shear-critical beams (Figure 19): the maximum deflection of beam BR100BS1 (RCA in the tension zone) was 16% greater than that of beam BR100TS1 (RCA in the compression zone). These findings consistently demonstrate that incorporating recycled aggregate into the compression zone of concrete beams enhances structural performance and deflection control compared to its use in the tension zone.
